CONCRETE PAVEMENT FOR AIRFIELDS AND OTHER HEAVY-DUTY PAVEMENTS

PUNCHLIST / WALK 2/10/16

P465 AIRCRAFT HANGAR WALK THROUGH PHASE I CAROTHERS/NAVFAC SIGN-IN SHEET

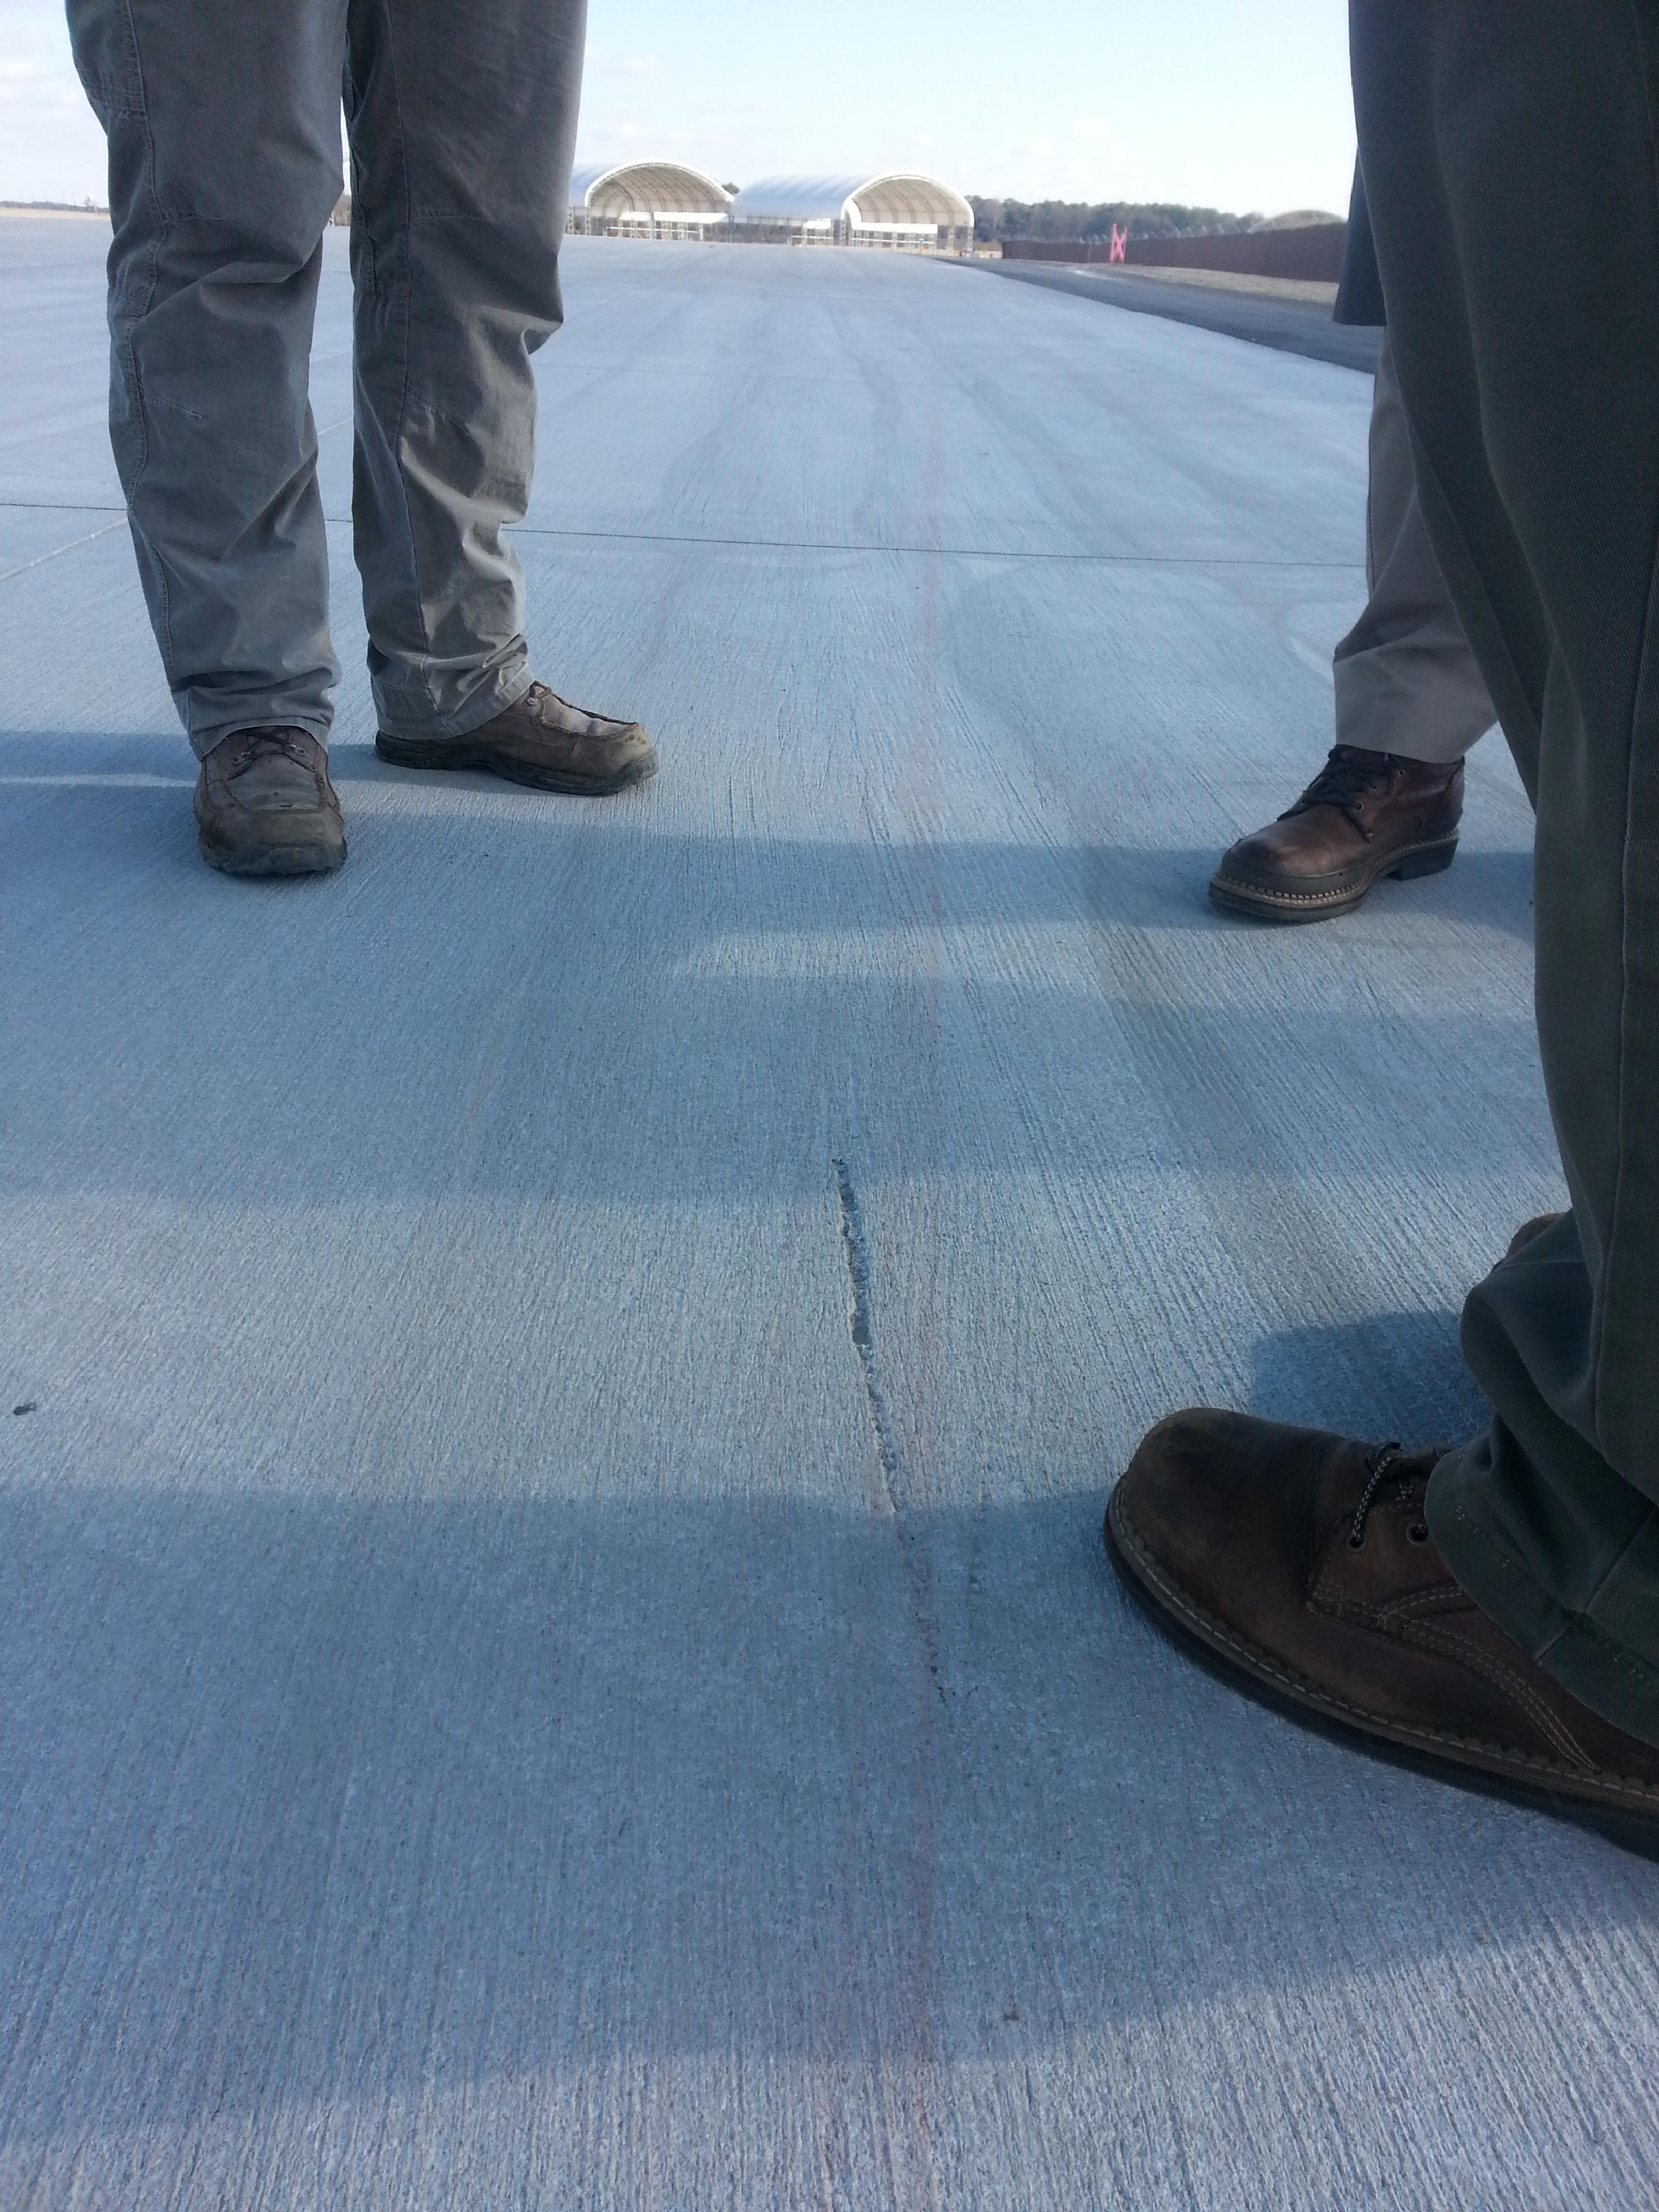
- 2. Striping (Environmental Conditions) Separate DFOW
- 3. Joint Sealants (Environmental Conditions) Separate DFOW
- 4. Asphalt overage on HD Paving edge or Broken concrete-See pictures
- 5. Surface irregularities-See pictures
- 6. Concrete slag in spots-remove
- 7. Grade at North East end and South West end of taxiway needs rework in green space.

Please note that coordination between PMO/NAVFAC/AirOpps/Carothers must take place in order to correct items 2-7.
